**DEPARTMENT OF TRANSPORTATION****DIVISION OF ENGINEERING SERVICES**

Contract #: 04-0120F4Cty: SF/Ala Rte: 80 PM: 13.2/13.9File #: 69.28**WELDING INSPECTION REPORT****Resident Engineer:**Siegenthaler, Peter**Address:** 333 Burma Road**City:** Oakland, CA 94607**Report No:** WIR-016764**Date Inspected:** 07-Sep-2010**Project Name:** SAS Superstructure**OSM Arrival Time:** 1900**Prime Contractor:** American Bridge/Fluor Enterprises, a JV**OSM Departure Time:** 700**Contractor:** Zhenhua Port Machinery Company, Ltd (ZPMC), Changxing Island **Location:** Shanghai, China**CWI Name:** See below**CWI Present:** Yes No**Inspected CWI report:** Yes No N/A**Rod Oven in Use:** Yes No N/A**Electrode to specification:** Yes No N/A**Weld Procedures Followed:** Yes No N/A**Qualified Welders:** Yes No N/A**Verified Joint Fit-up:** Yes No N/A**Approved Drawings:** Yes No N/A**Approved WPS:** Yes No N/A**Delayed / Cancelled:** Yes No N/A**Bridge No:** 34-0006**Component:** Tower and OBG Components**Summary of Items Observed:**

## WELDING INSPECTION REPORT

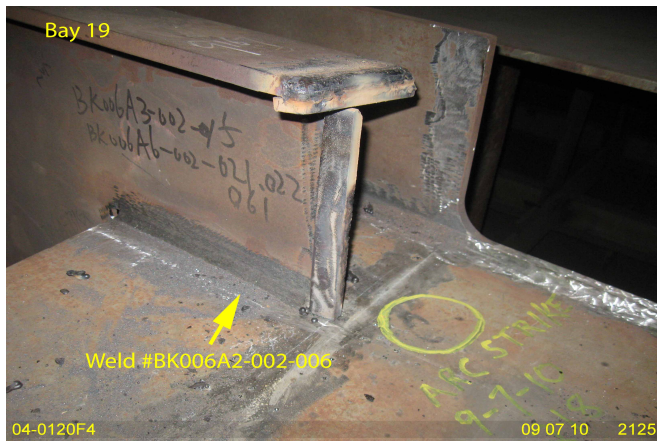
An apparent arc strike adjacent to weld joint BK006A2-002-006 located on PCMK 70BK11. This QA Inspector clearly marked the area and informed ABF Representative Kelvin Cheung and ZPMC CWI Wu Shigao, who were both present and observed same. See photo below.
